All models

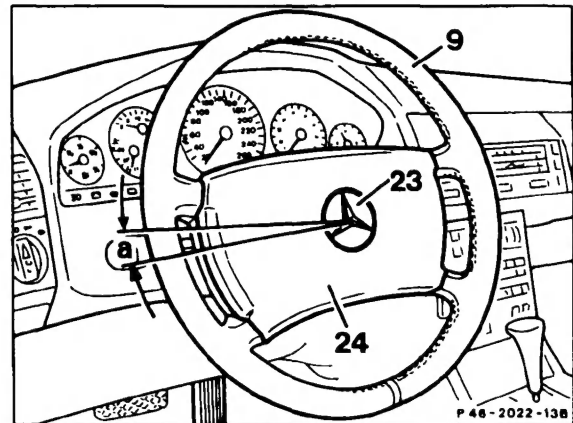
- In steering center position, maximum allowable play (a) at steering wheel is 25 mm.

a = max. 25 mm

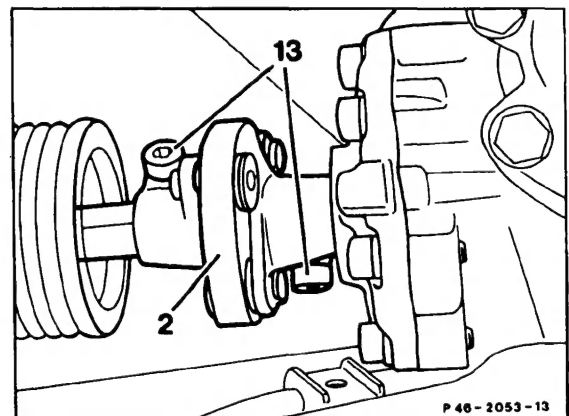
Models 124 (except 124.034/036), 129, 201

- On all models starting 04/1984, check play of steering coupling or of both flexible couplings (2).

2 Flexible coupling

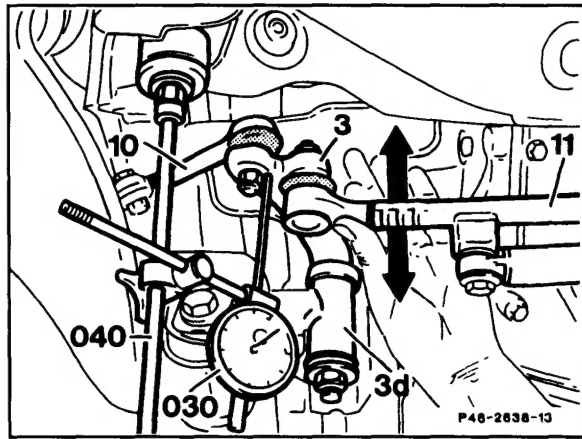
All models except 140

- Check mounting of idler arm (3) in rubber bushings, using dial indicator as necessary (SMS Job No. 46-0110). If play is greater than 0.5 mm, replace rubber bushing (SMS Job No. 46-0520) on separate order.

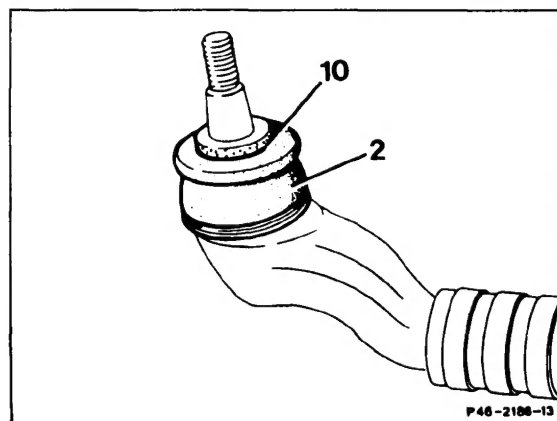
If a damaged rubber or plastic boot is found, replace affected joint immediately, since penetrating dirt will destroy joint in a short time. **Replacement of only the boot is permitted only if no dirt whatsoever has entered the joint.**

2 Rubber boot
